Real Estate Inspection Report

Hayes Inspection Group

SAMPLE REPORT

BUILDING TYPE: Commercial Building.

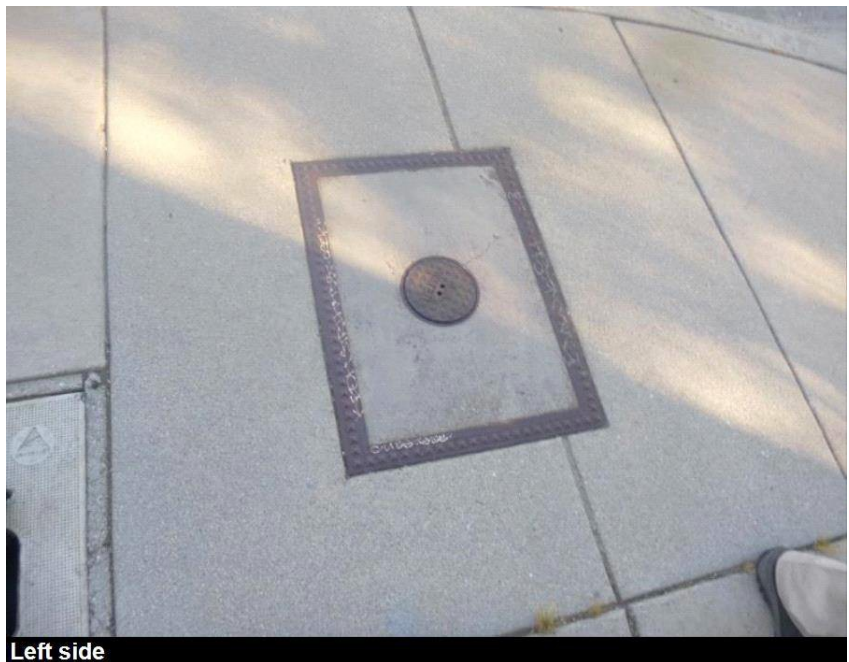
MAIN WATER SHUT OFF
LOCATION:

There was no main valve seen at the building except at the water meter.

Needs Attention: No main water shut off valve was located at the outside of the building. This is typically required as for repairs and emergency shut off, and this should be located or one may need to be installed by a plumbing contractor.

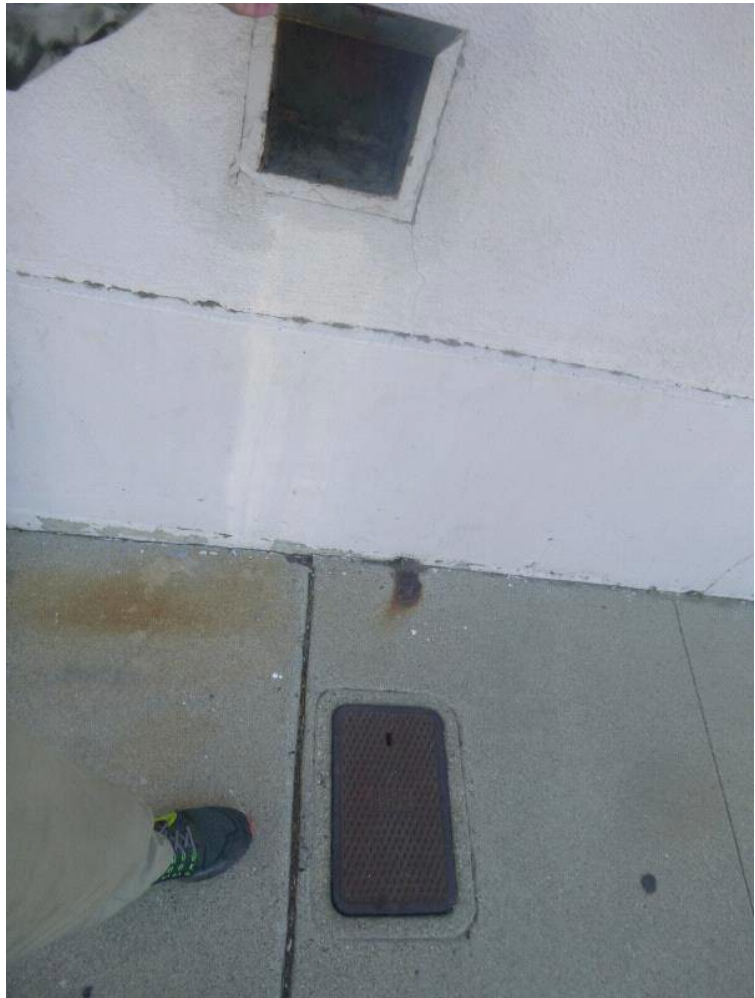
Note on the left side there is what appears to be an old water meter and a space for a water shut off for the building which are both empty and it is suspect this was abandoned when the building was repiped with newer copper.

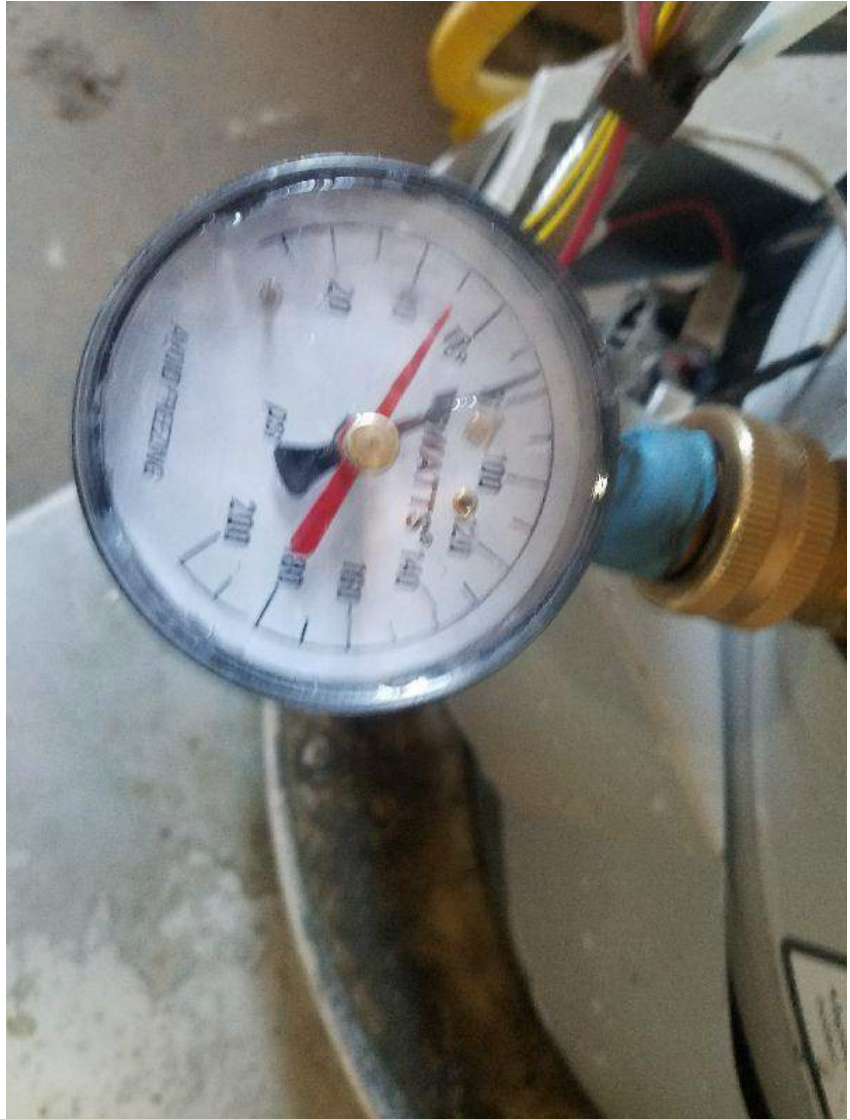
WATER PRESSURE:

80 psi, this is serviceable. This is the maximum recommended pressure.

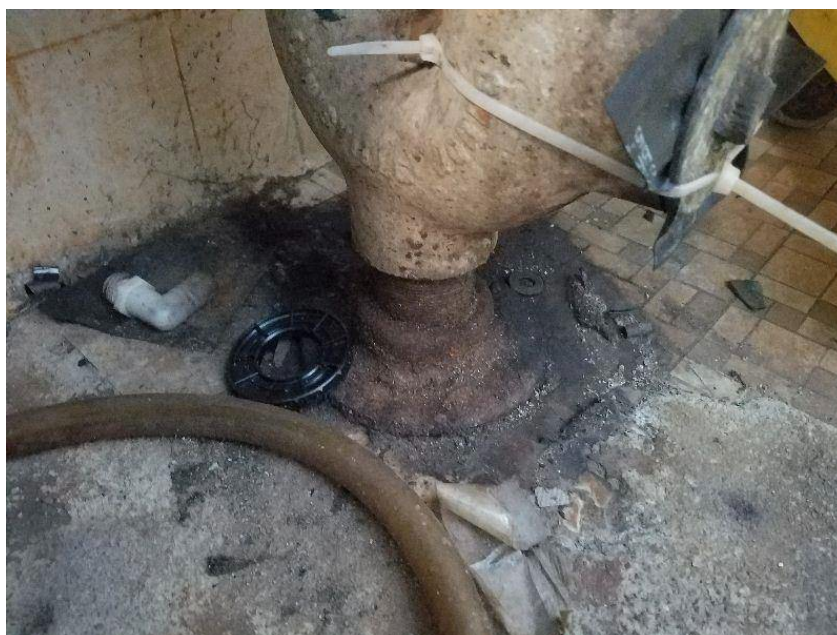
Needs Attention: There are rusty areas on the exterior of the older waste lines. It is not possible to tell when but they will need replacing in the future as they continue to wear out. The rusty scales on the inside tend to catch debris and clog easier than newer plastic drain lines.

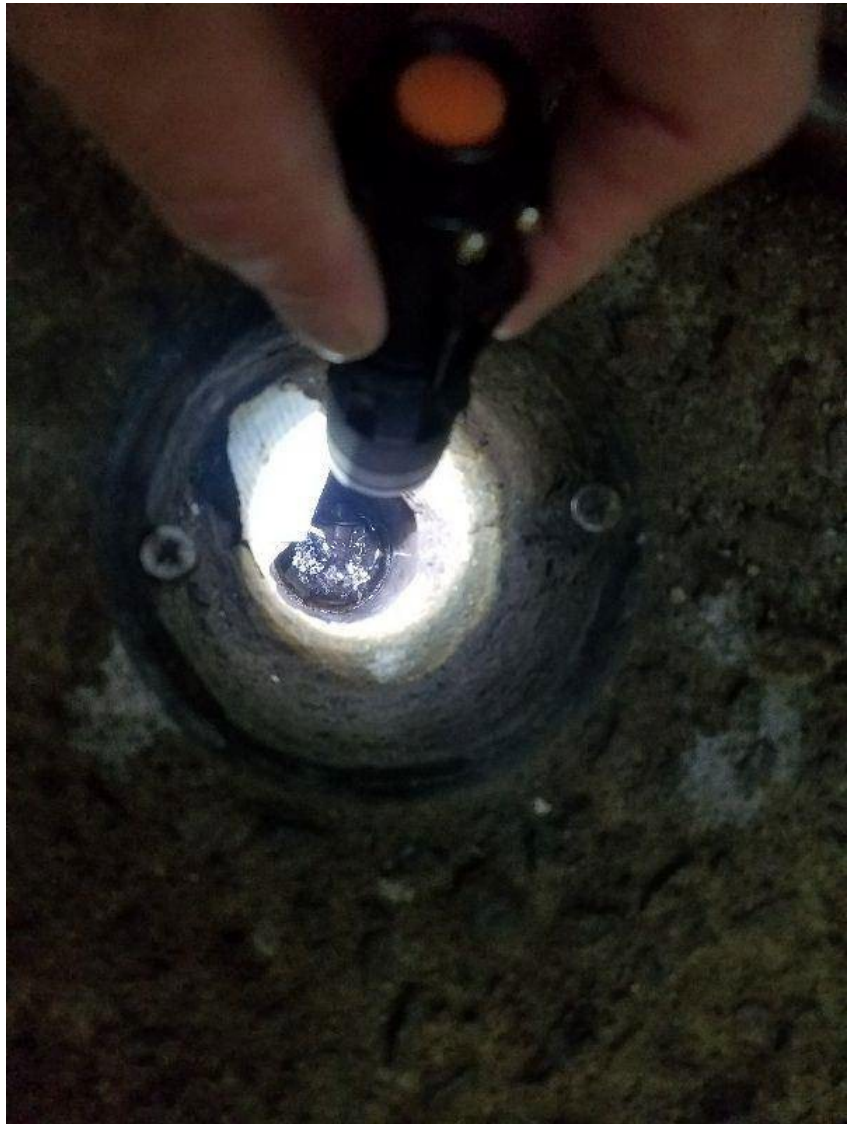
Needs Attention: Older drain lines under slab, seem at floor drain in janitor closet.

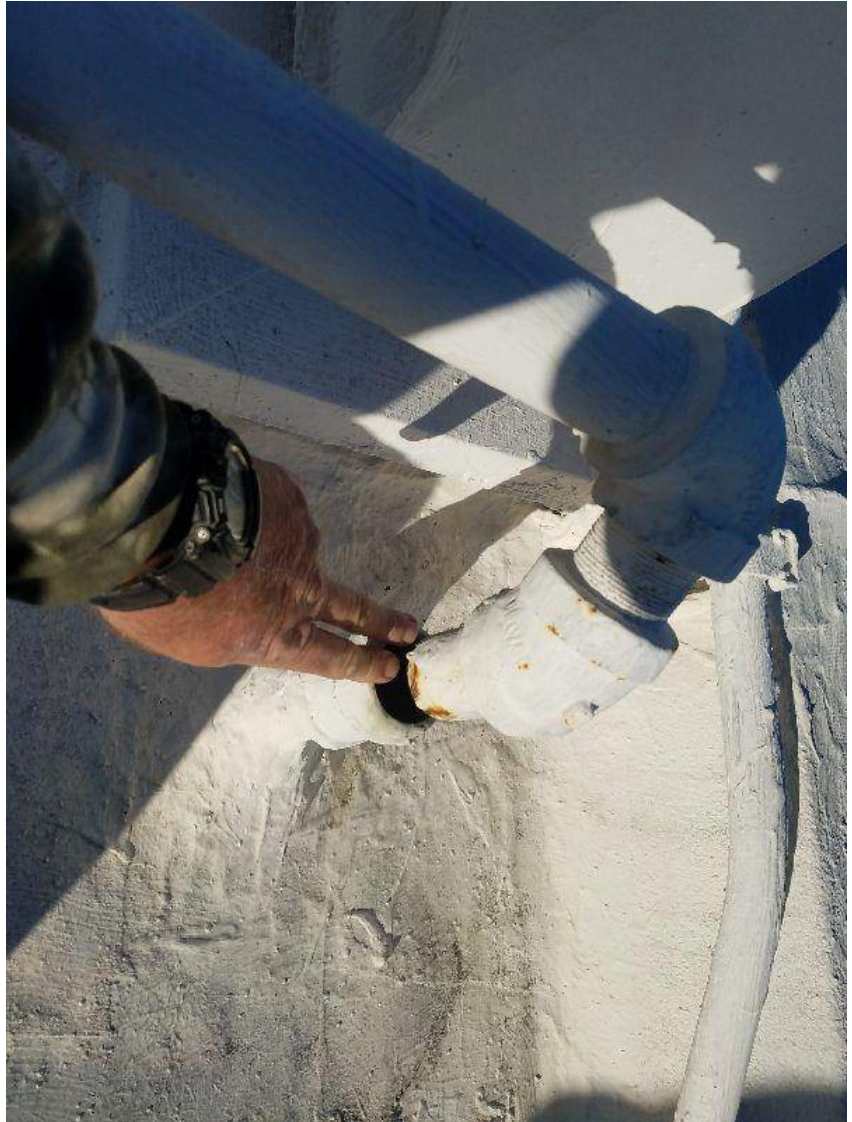
Needs Attention: These are older vent pipes on the roof and one of them is disconnected I need servicing.

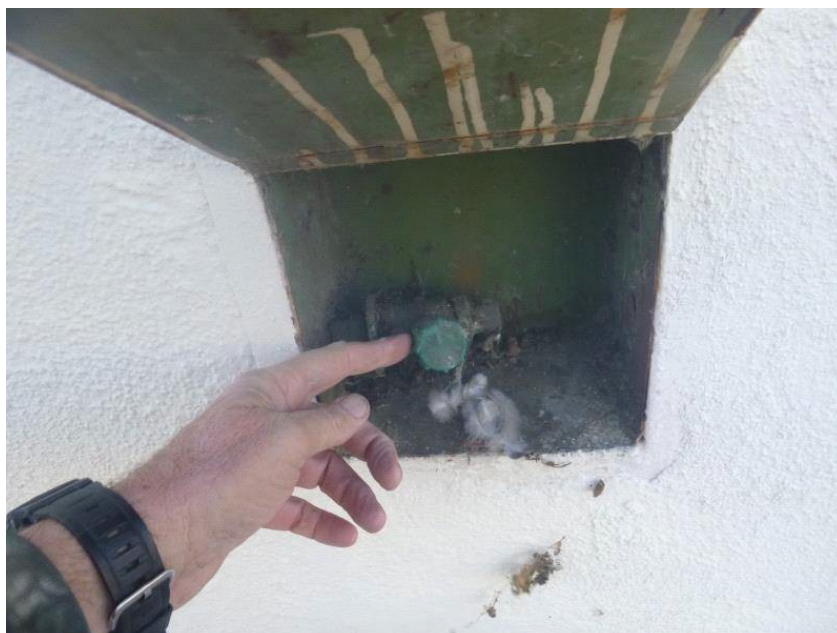
There is a missing handle on the exterior hose faucet on the exterior hose faucet on the left side behind the utility door. This is capped off and is unknown if it operates.

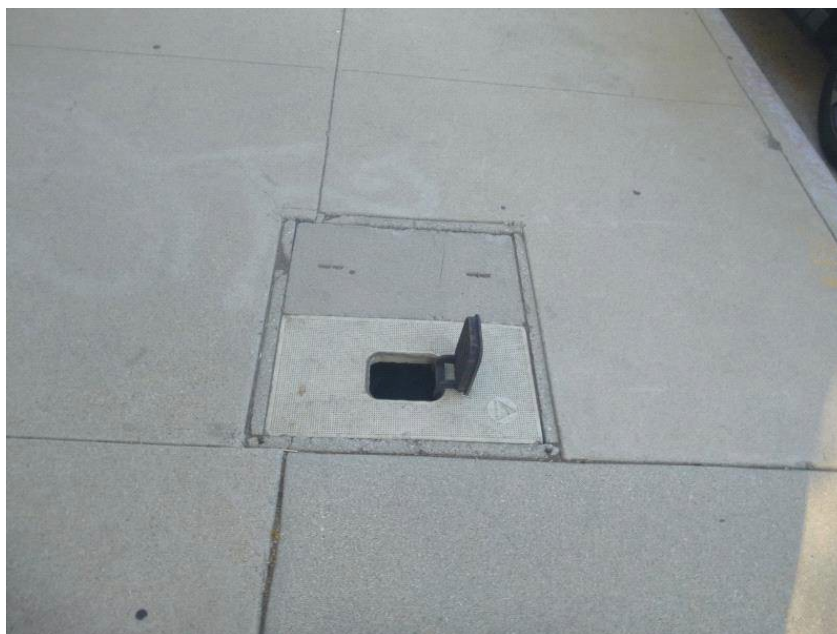
SEISMIC GAS SHUT OFF VALVE:

There is no automatic seismic gas shut-off valve on the main gas line. This may need to be installed before the close of escrow.

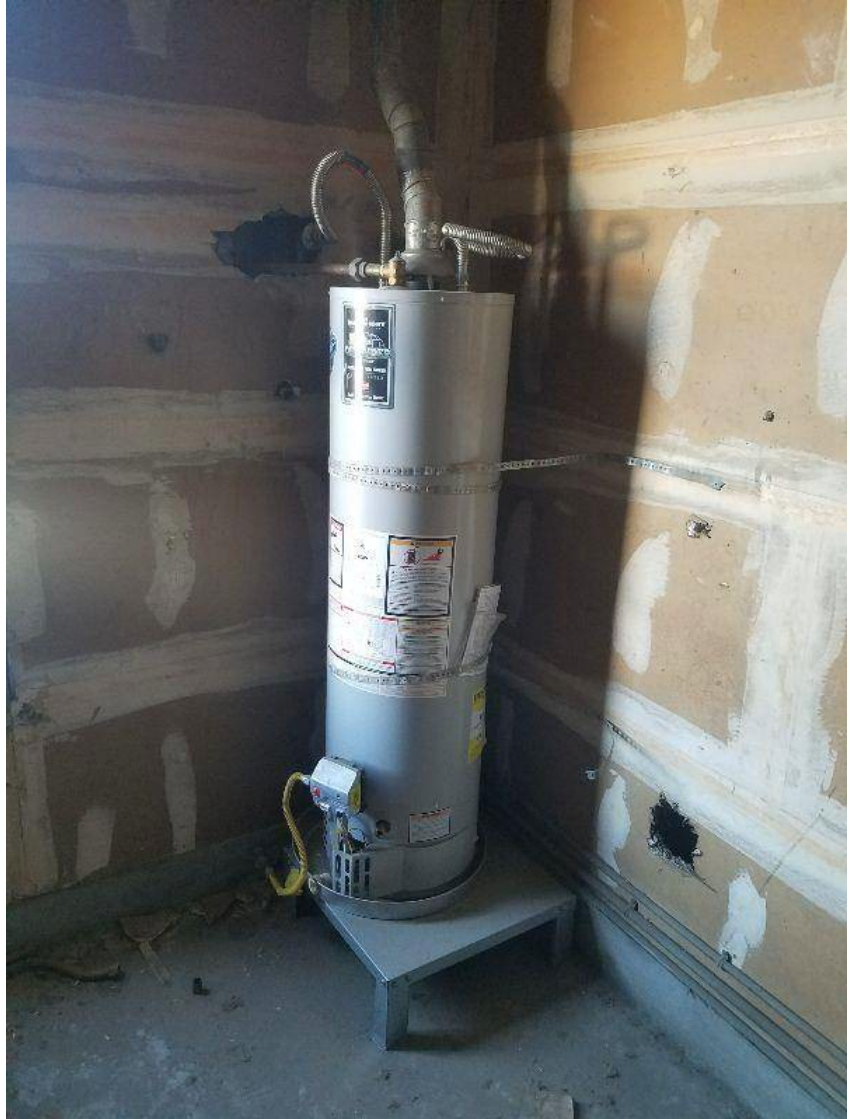
The water heater is located in the roof closet.

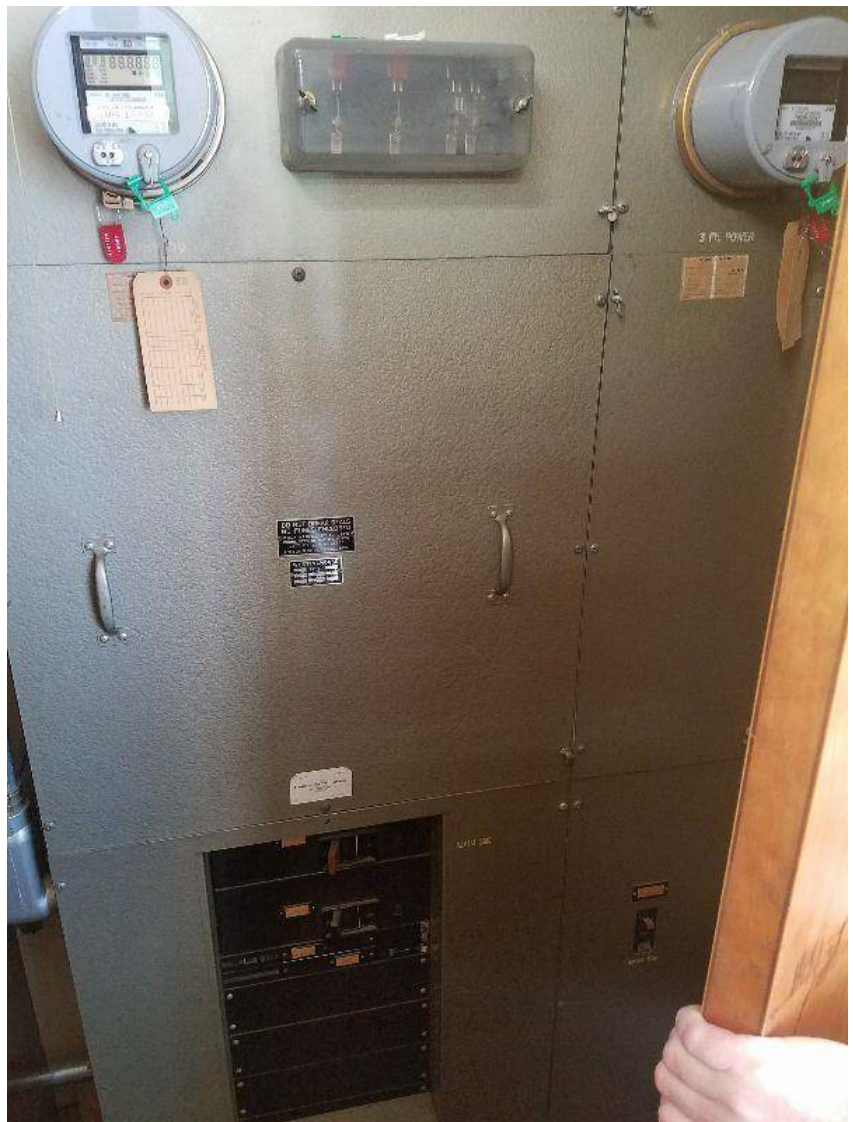
MAIN PANEL LOCATION:

This is in the upstairs office closet area.

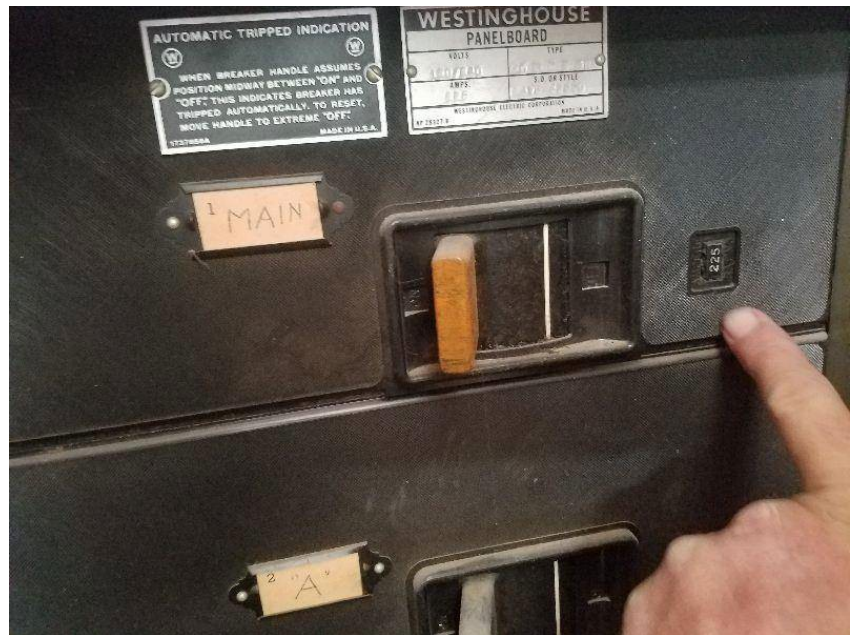
MAIN PANEL AMPERAGE:

Service Amperage - 225 Amp stand up panel for the main panel

There is a second meter for 3 phase power which has a 100 amp circuit breaker

Needs Attention: this panel and circuit breaker system is an old system. It is nearing the end of its expected life span. As with all older systems it will be more prone to failure due to its age and design. Some of these older systems have a reputation for unreliability, failing to trip, jamming, or overheating. Some electricians may recommend the panel be replaced and upgraded for safety.

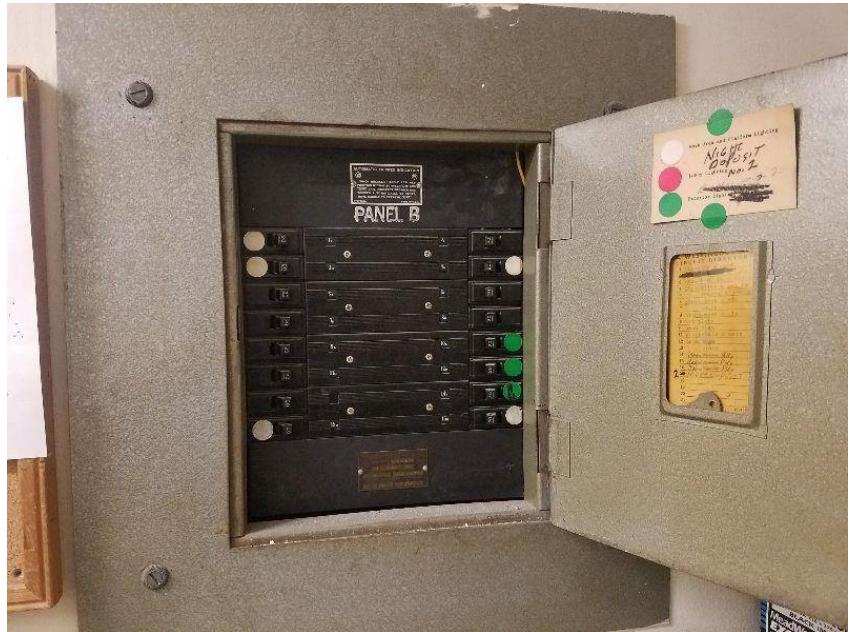
This sub panel B is upstairs in the hallway.

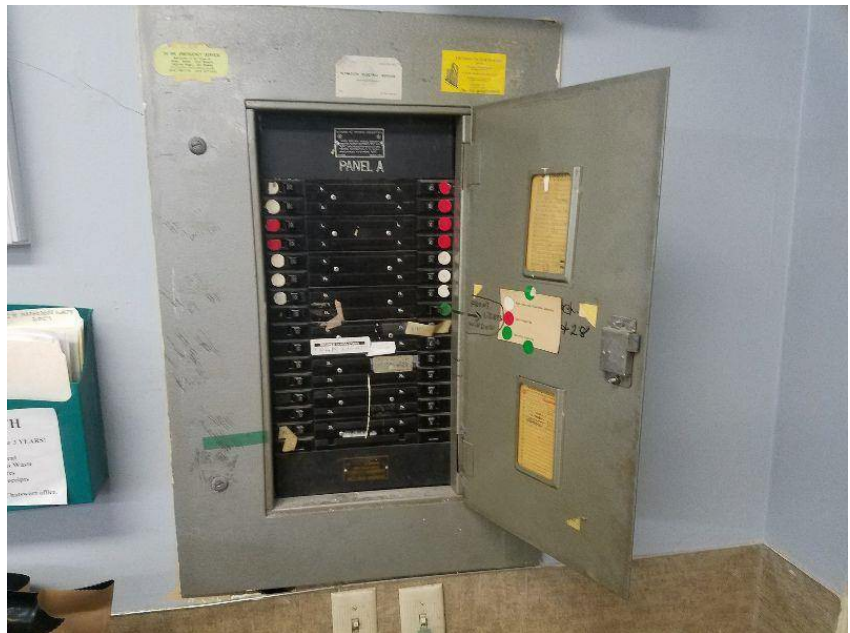
This panel a is downstairs in the main room near the janitor closet.

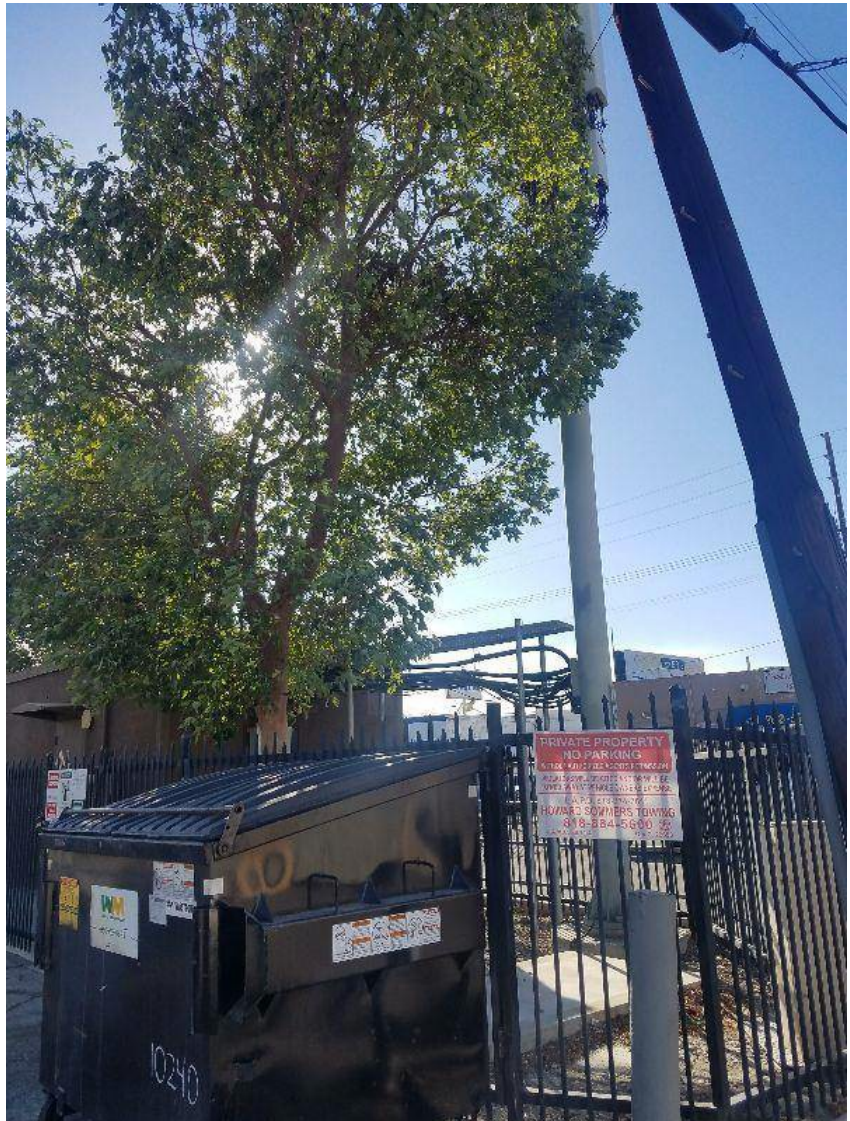
There is a cell tower in the back parking lot on the West Side along with a small maintenance building which is reported as being part of this property under a long-term lease. Check with the owner for more information and documents.

Note the electrical system appears to be possibly undersized and extensive upgrades should be expected. An electrical contractor should be consulted along with the architectural designs for future equipment .

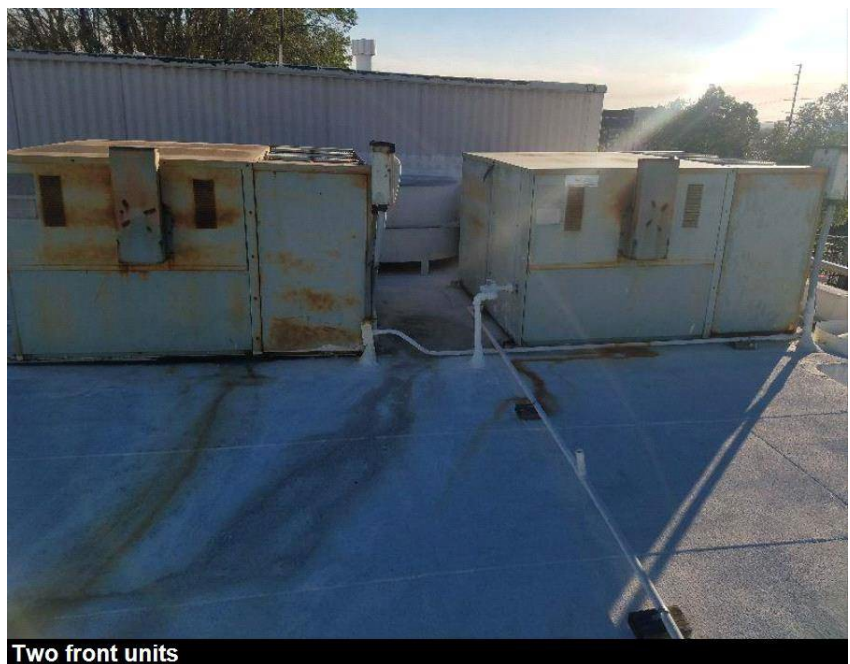
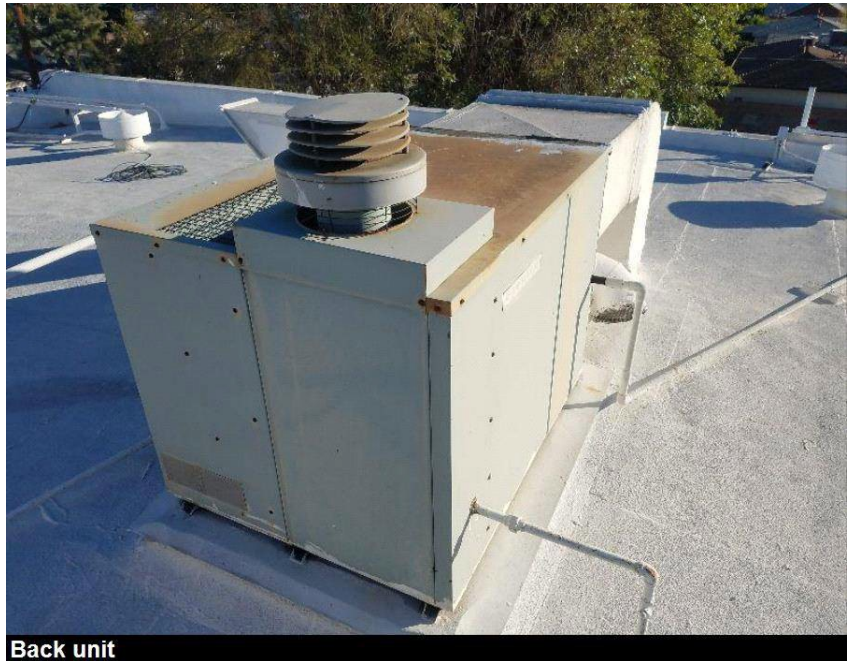
The heating units are located on the roof.

CONDITION: **Needs Attention**, The two front units are very Rusty and with water stains and the left unit has the gas line turned off to it and the right unit has the gas turned on to it but this was not tested.

Not Acceptable, These two front units are both very old and unreliable probably need replacement instead of any repairs.

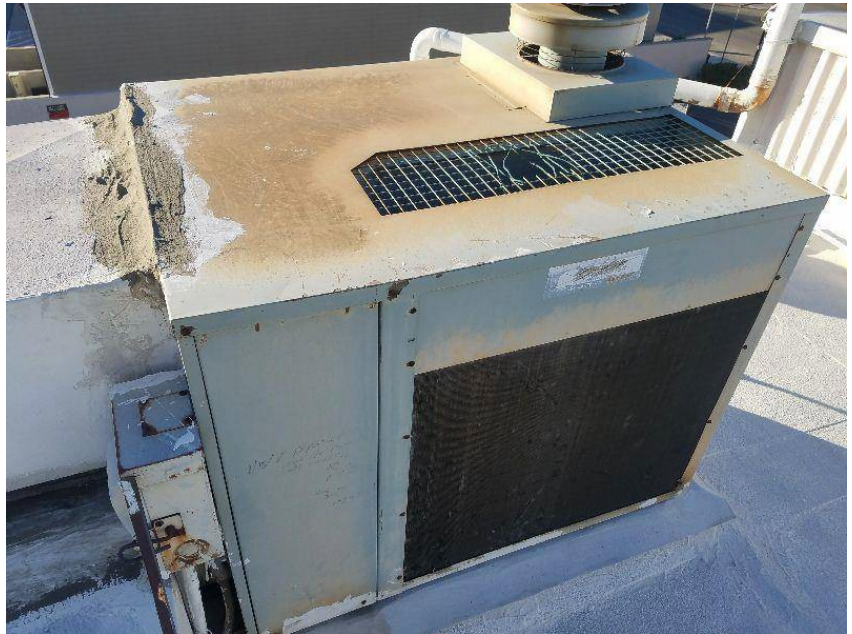
Needs Attention, this is a very old unit also and not reliable and should be planned for a replacement.

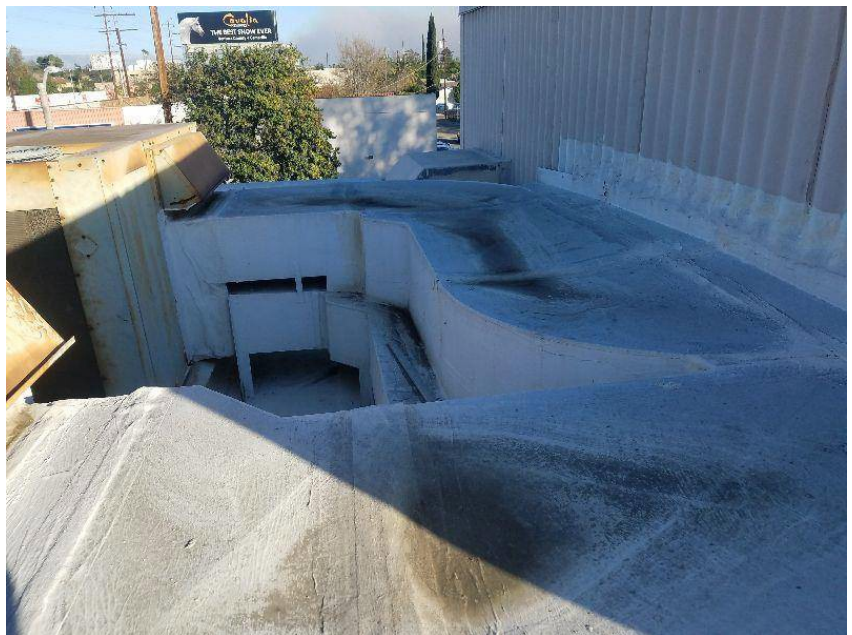
DUCTING AND AIR FLOW:

These roof ducts typically have fiberglass duct liner seen inside the duct past the filter. Though this is allowed by code, the microscopic fibers can be a respiratory irritant. This can be sealed with a water based varnish and encapsulated.

Needs Attention, There are ponding stains on top of the text indicating this does not drain off properly when raining.

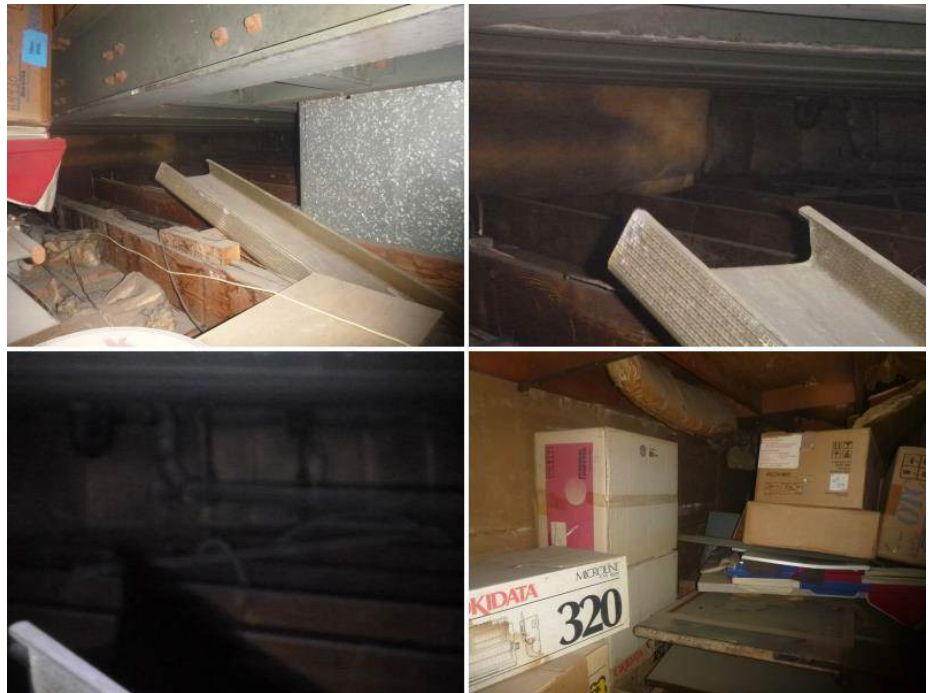
There is a door in the upper office area for access to the above front office areas above the ceiling. (This was viewed from the door way only and is a difficult climb through the attic)

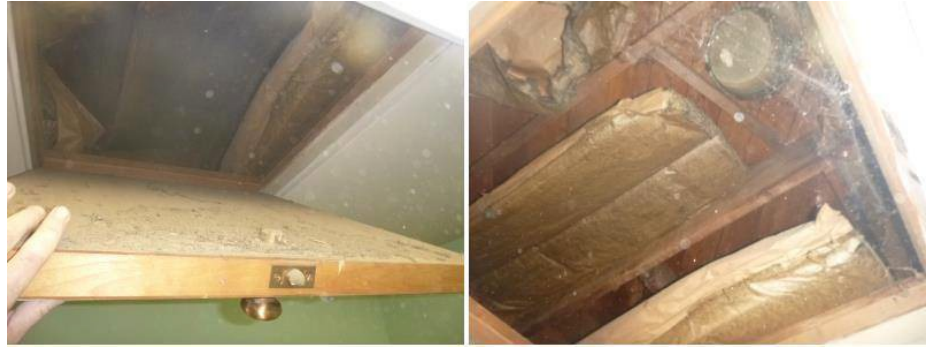
There are two ceiling hatch doors in the upper office which when partially opened had a lot of dust.

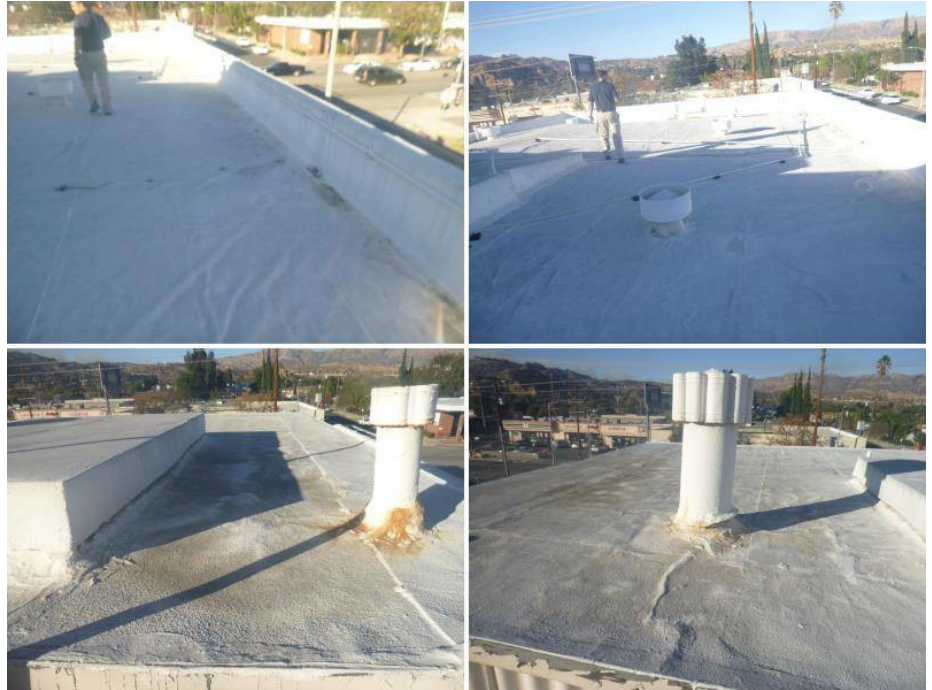
The roofing material on the low sloped roof is rolled sheet composition roofing with a granular surface which has had a white coating put over the top of it.

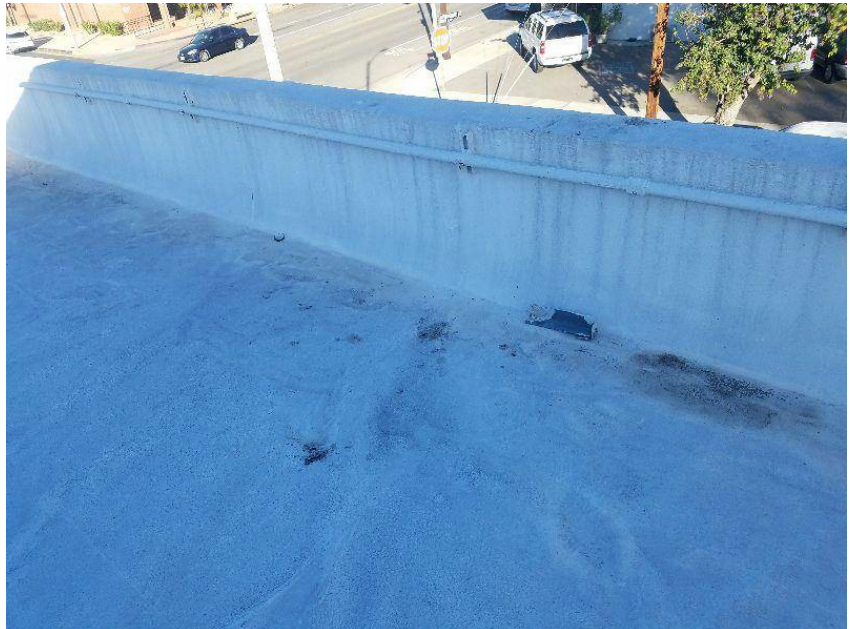
Needs Attention: On the low sloped / flat roof, There are some areas showing that the water ponds a little bit such as long the sides as it goes to the drain.(There are moisture stains in the lower hallway at this area indicating some past leak.)

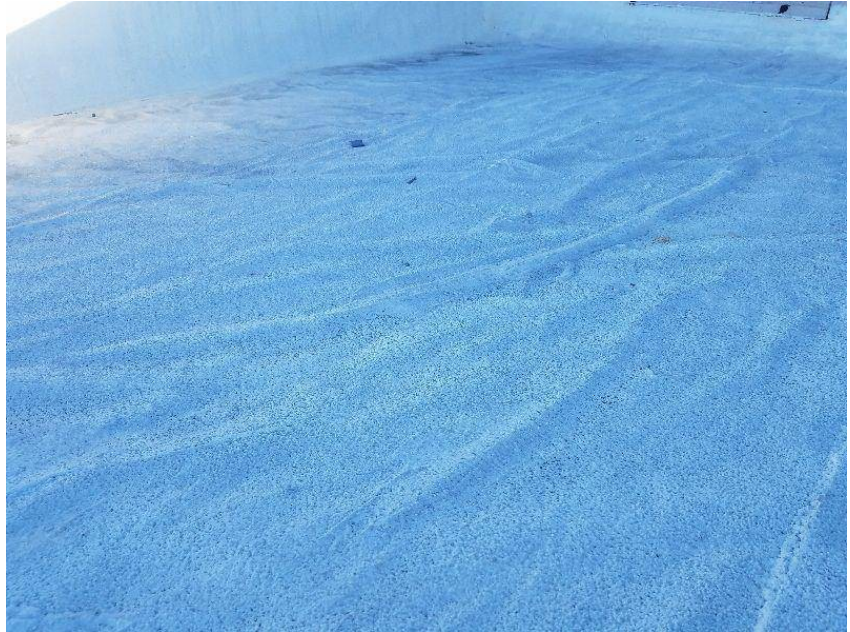
Needs Attention: There are many wrinkled areas which have just been wait, headed over that's what I.

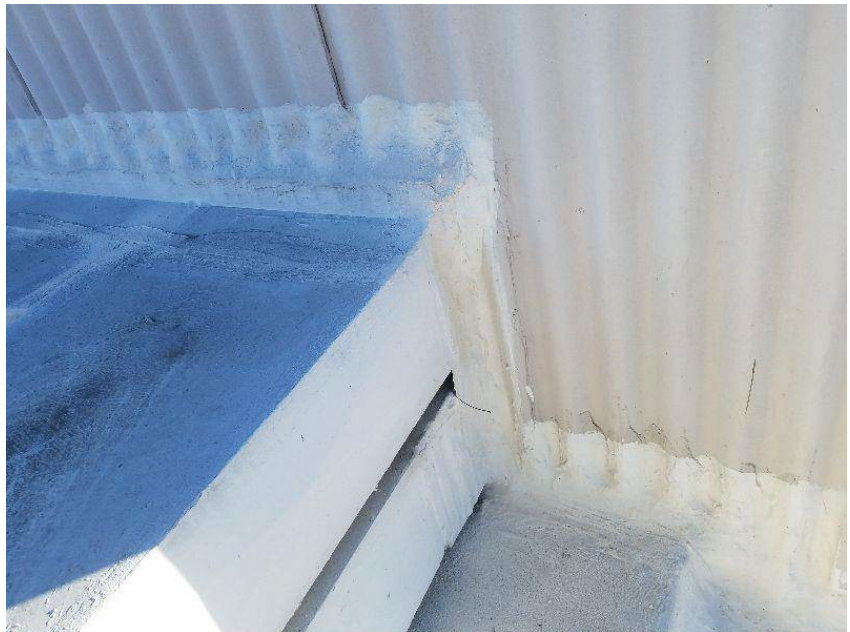
Is generally appear service of all but there are some water stains in damage glow the furnace location and where the ducts penetrate the concrete wall and platform. In the past probably should be designed to prevent future leaks even though it has caulking and Mastic now that is not reliable.

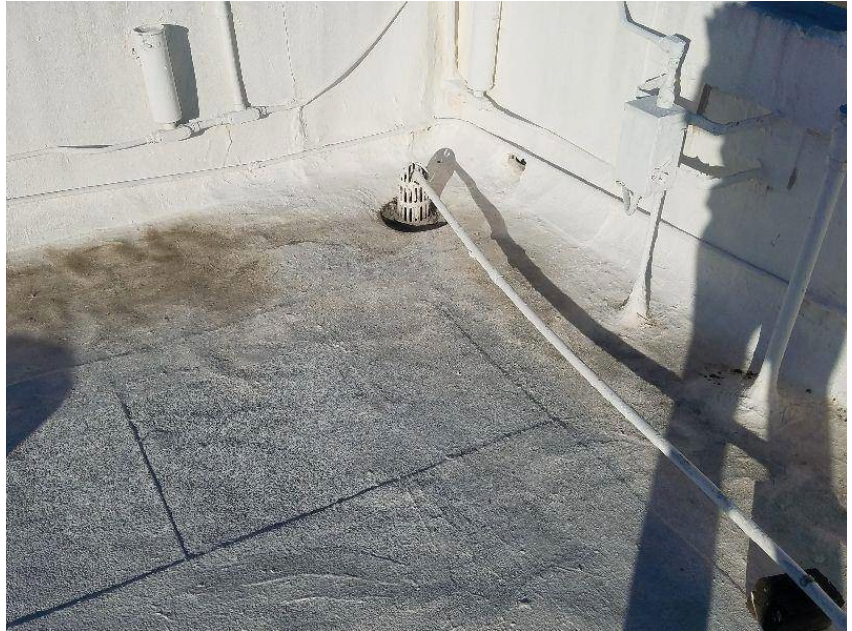
There are roof drains installed in the low areas of the flat roof to direct water off of the roof.

There is moisture damage on the ceiling below the front left roof drain. In the piers of the roof has been repaired in Seal.

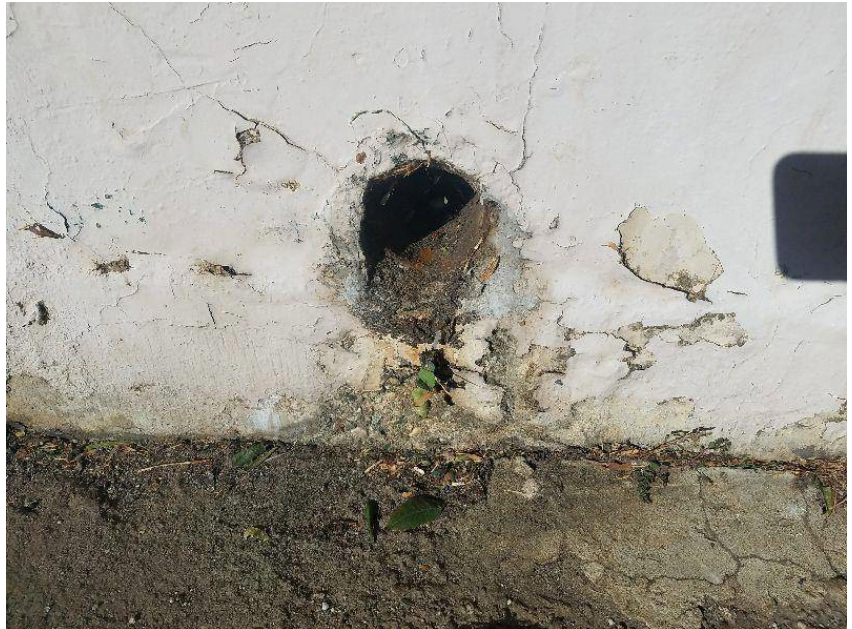
The roof drain empties at the back alley on the back side of the building and is showing some peeling paint and deterioration since the downspout does not extend out past the building face.

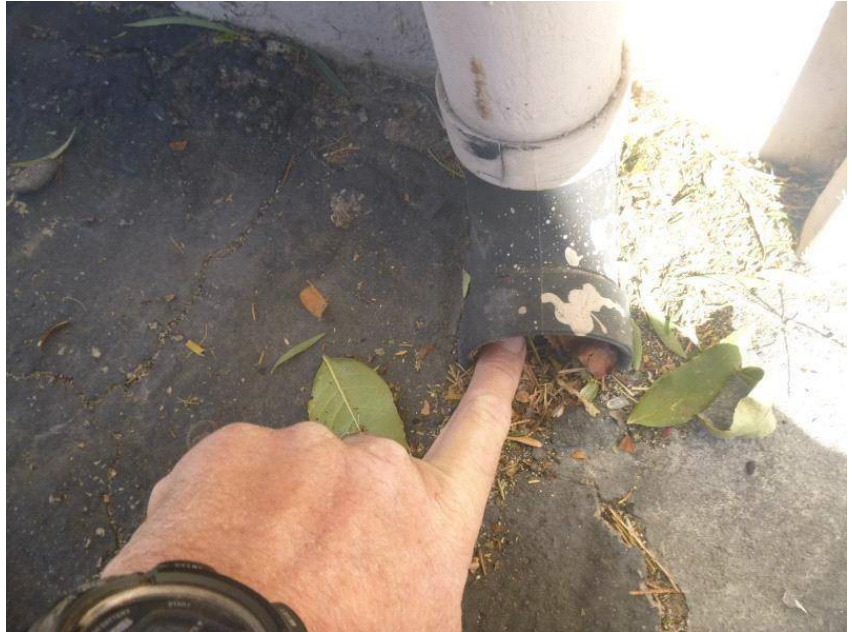
Needs Attention: there is a very small roof drain downspout on the right side near the front. This is partially buried in the asphalt and has debris clogged at the bottom.

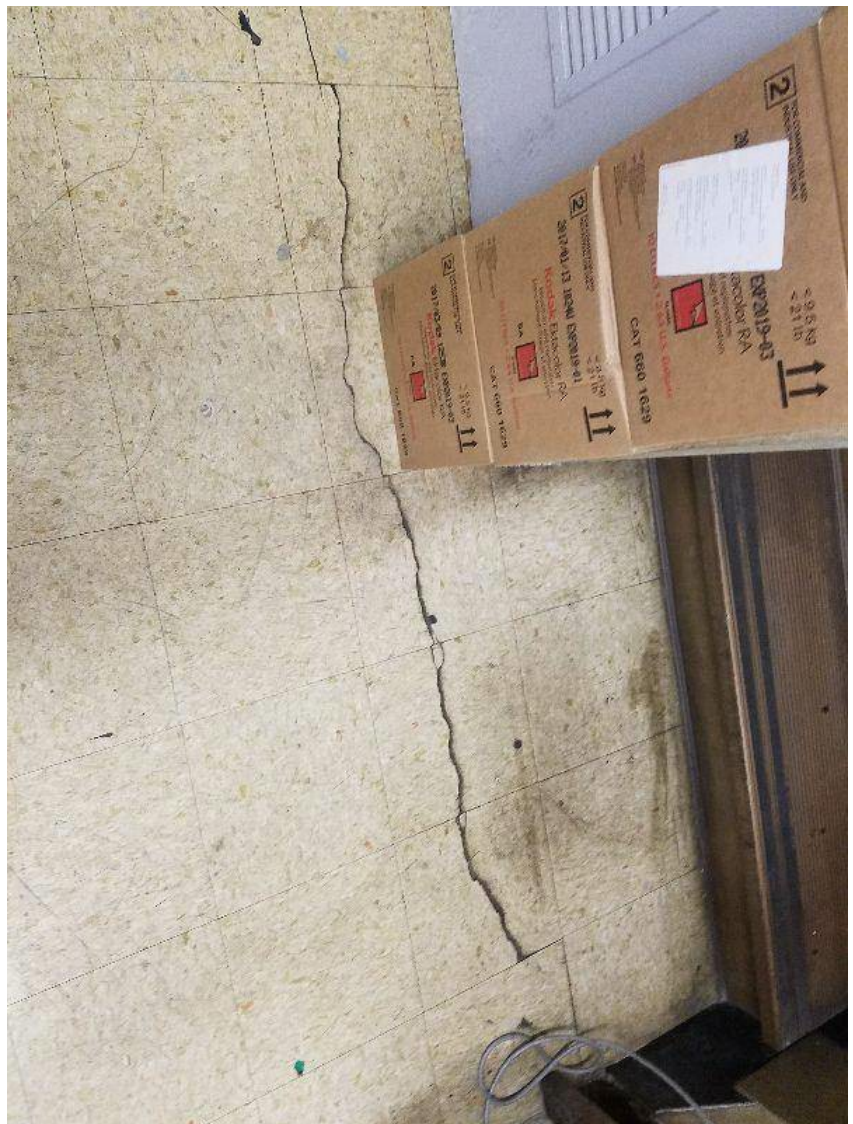
There is a crack in the concrete floor at the bottom of the stairs showing through the linoleum tiles. This does not appear to be a significant.

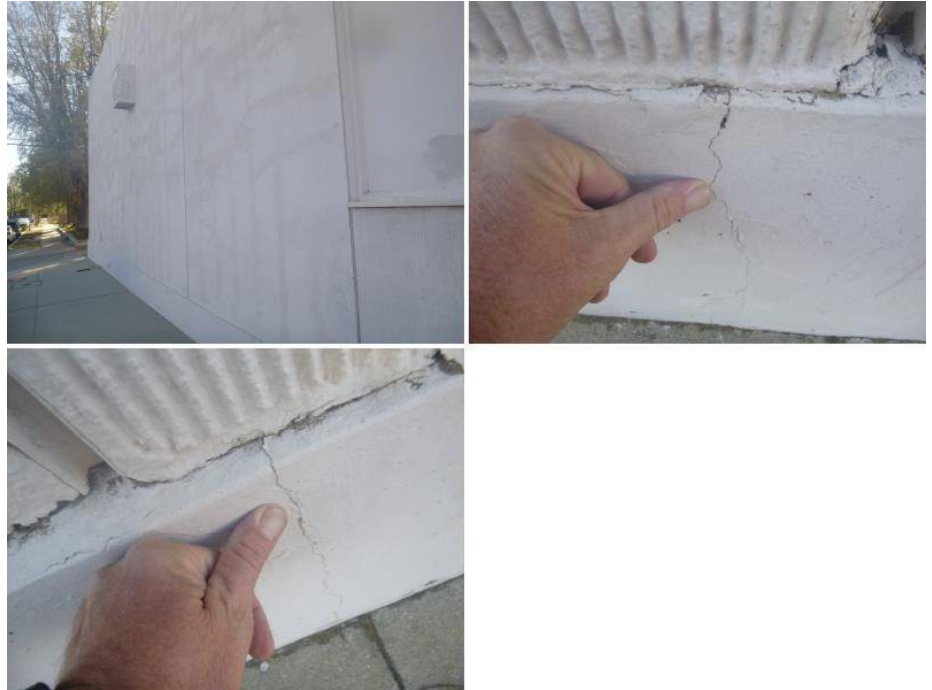
There are many small hairline cracks along the foundation footing visible along the left sidewalk area. These do not appear significant..

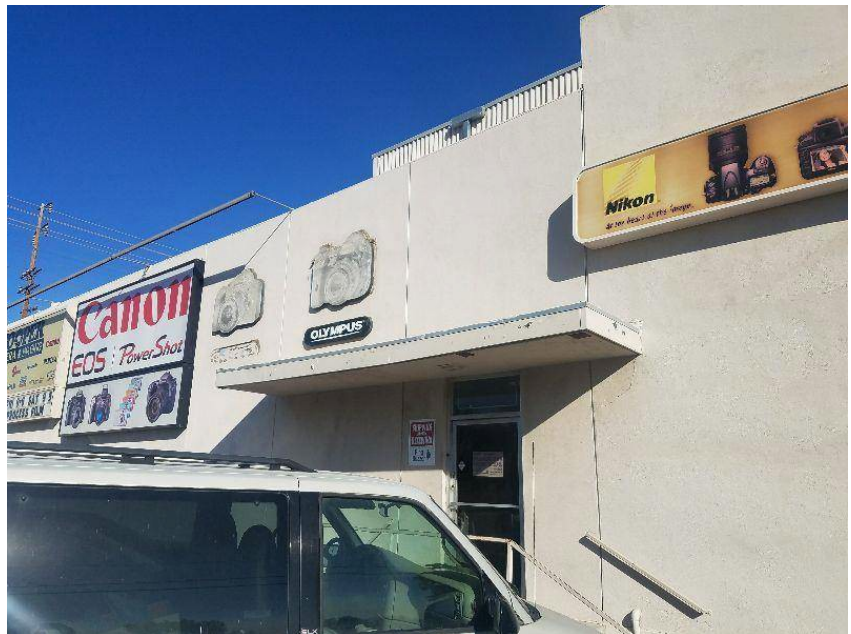
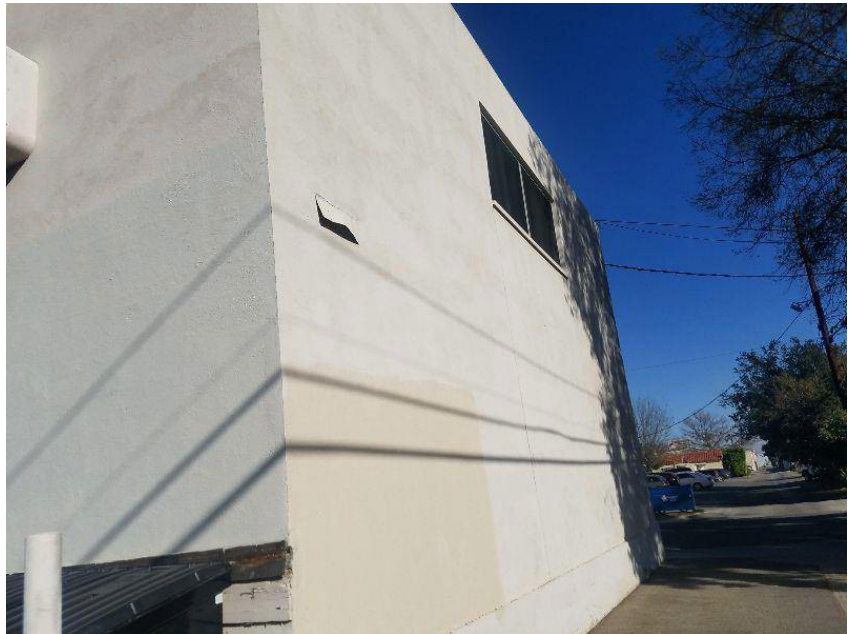
The exterior building covering appears to be a concrete panel building with some tile appliques on the front.

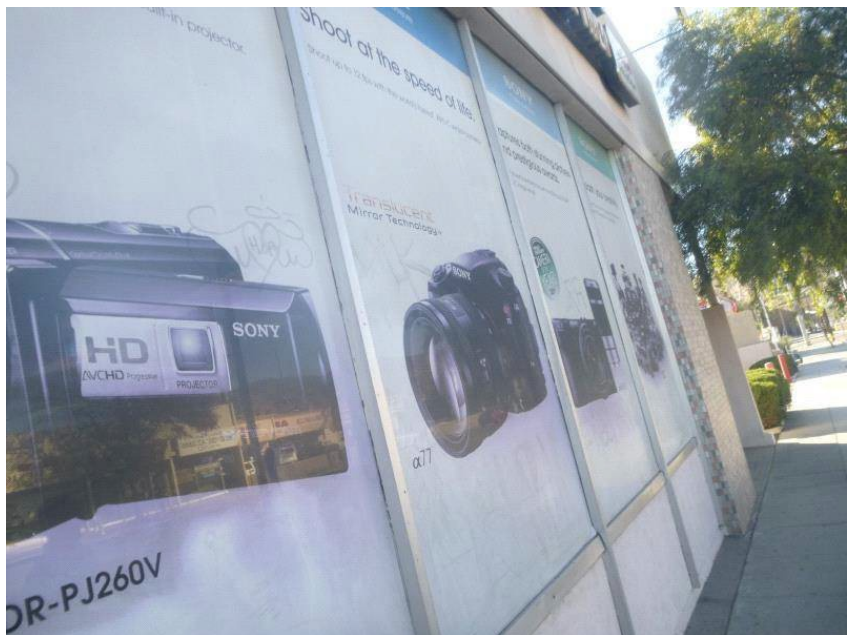
There are panes of glass that are within 18 inches of the floor, or close to the walkway along the front sidewalk and In newer construction it is required that the glass be a tempered type of safety glass. Making this older glass into safety glass by tempering or putting a safety film on it may not be a requirement for this sale but it is recommended.

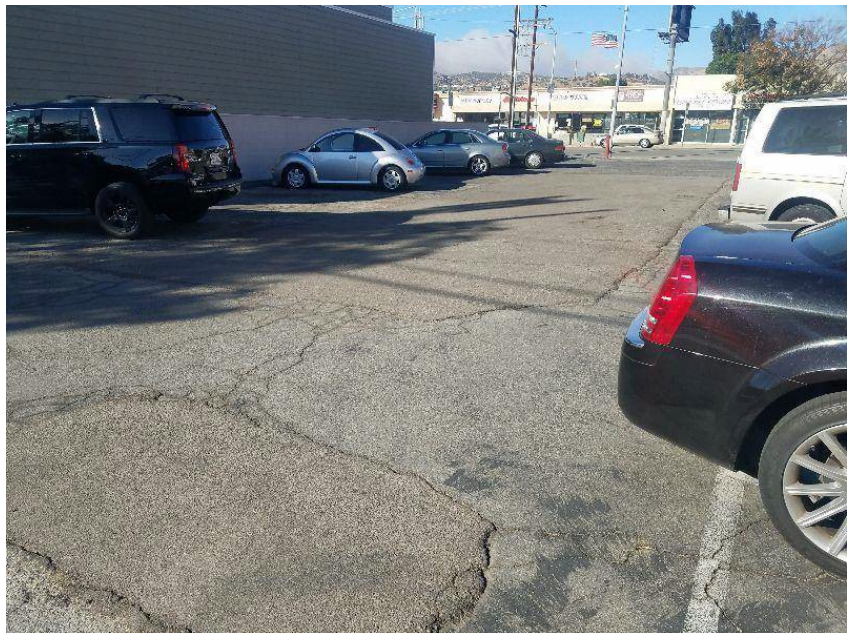
Needs Attention: There are deteriorated areas of asphalt due to typical wear and tear.
