Real Estate Inspection Report

Hayes Inspection Group

SAMPLE REPORT

BUILDING TYPE: Commercial Building.

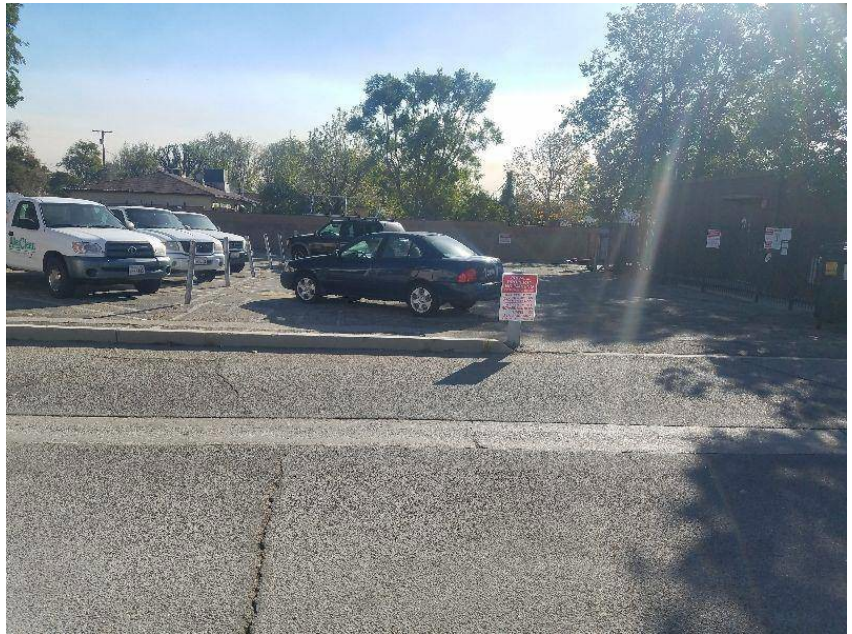
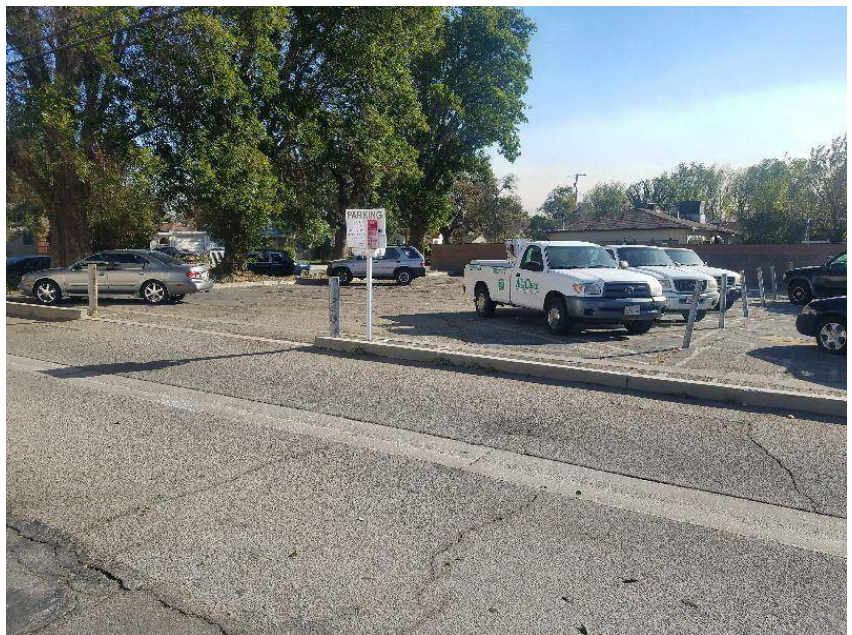
There is a parking lot across the alley in back of the building which is reported as part of this property. The asphalt in this back parking lot is also deteriorated and cracked in areas.

The parking spaces are marked and painted faintly. New sealant for all of the parking area should be expected and repainting the parking spaces.

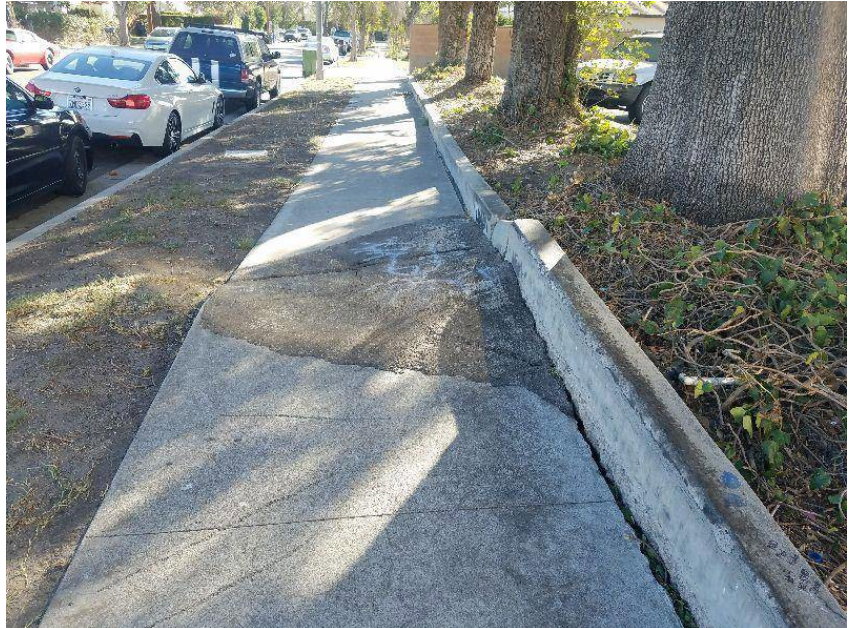
Needs Attention: There are raised and shifted areas of the walkways that appear to be a trip hazard, There are tree root systems causing shifting and cracking of the walkways, This is seen along the east the large trees at the back parking area.

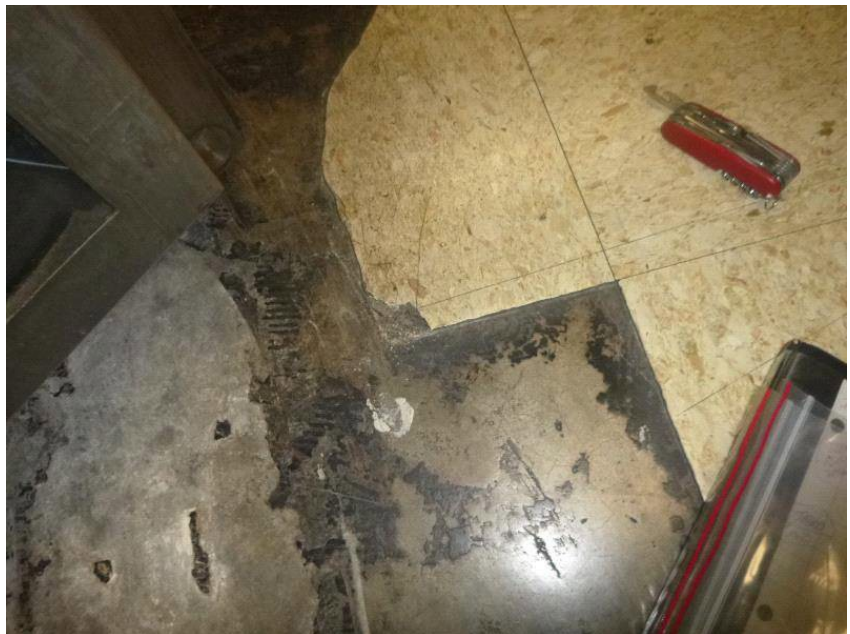
Needs Attention there are older 9" square tiles such as in the back lower storage rooms . These tiles are known to commonly have asbestos material and would have to be analyzed by a lab to determine if asbestos is present.

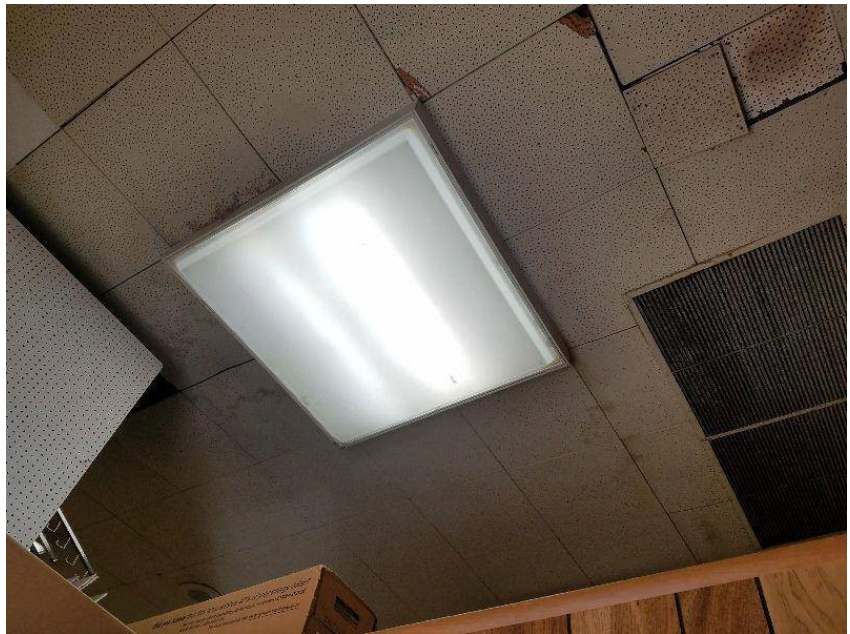
Needs Attention:

CEILING: There are areas of moisture stains on the ceiling on the right side middle Warehouse area (below front roof package heaters near the joints of the ducts entering the upper roof utility room: see roof section).

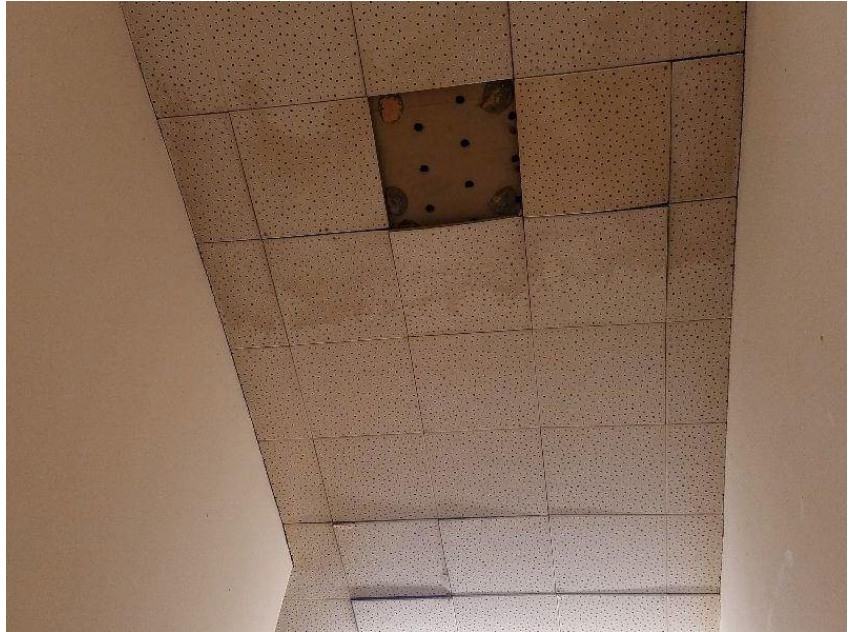
CEILING: There are areas of moisture stains on the ceiling above the stairs.(below the old roof utility room)

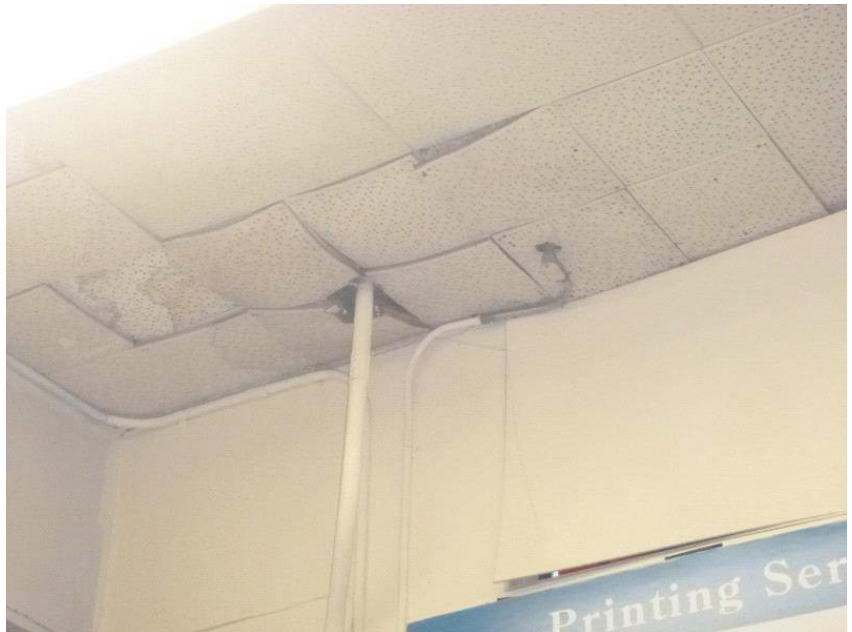
Needs Attention:
CEILING: There are areas of moisture stains on the ceiling near the front left corner where the roof drain comes down through the building.

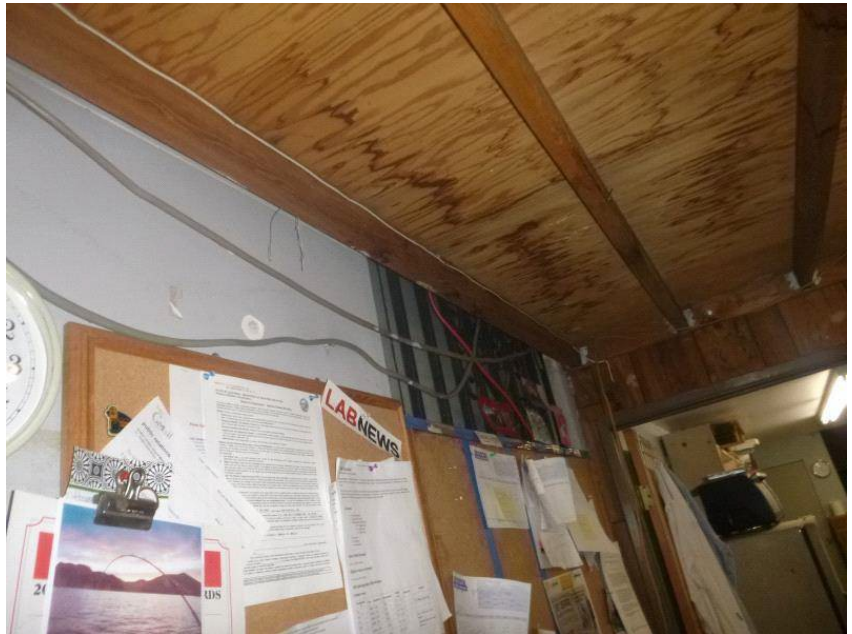
Needs Attention:

CEILING: There are areas of **moisture stains** on the plywood ceiling along the hall on the left side (this is below the area where water ponds on the roof along the left side)

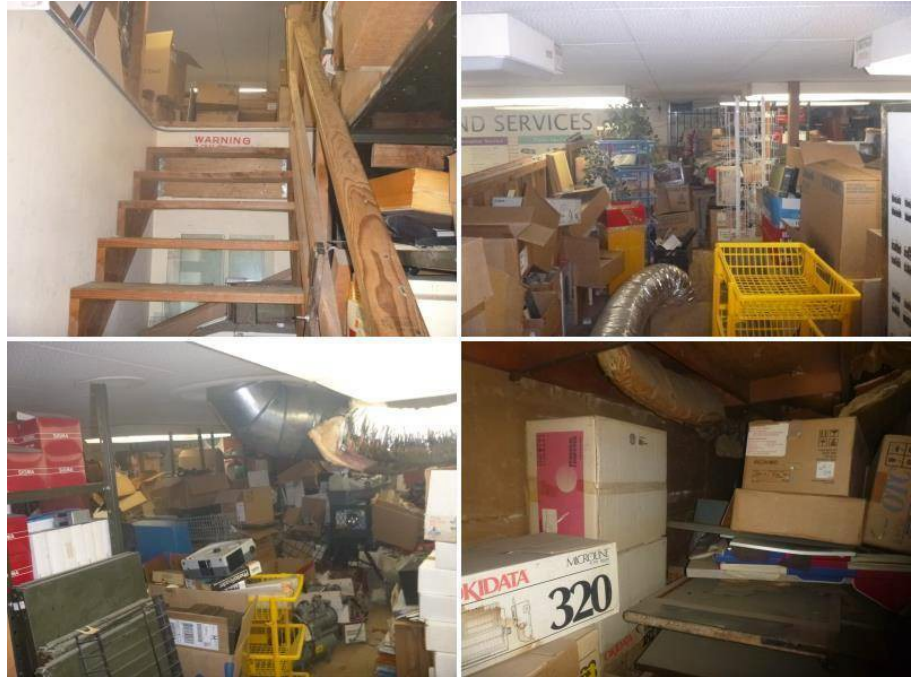
MEZZANINE

There is a storage section above the front offices accessed from stairs in the back warehouse. The head clearance is lower than normal and this area has many stored items and clutter.

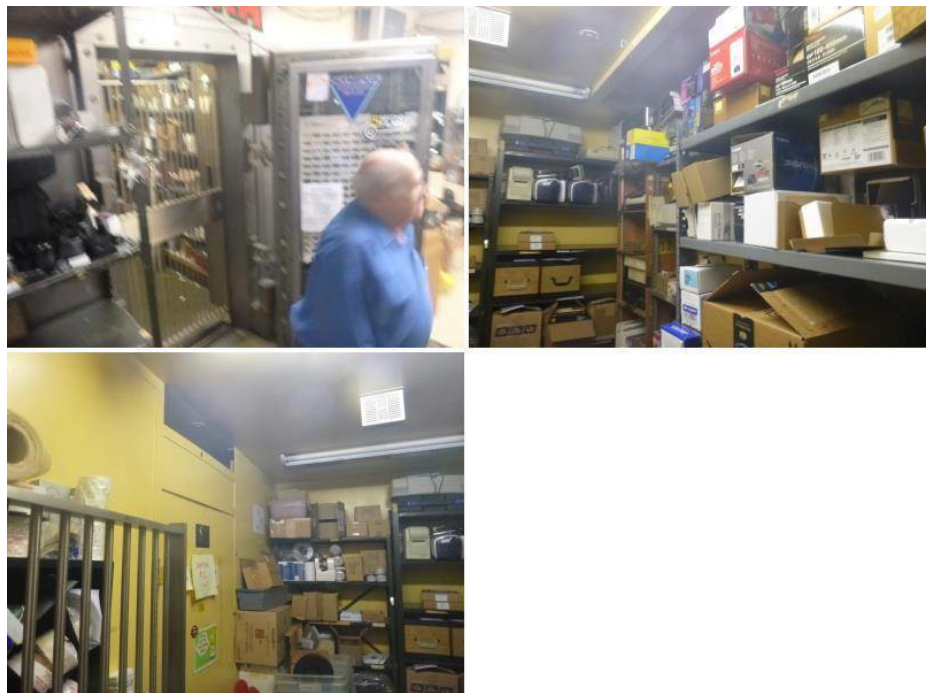
WALKIN SAFE

In the back on the main floor there is a large walk in vault. The tenant mentioned he has the combination and this operates. Check with the owner for more details and the history of this and any documents.

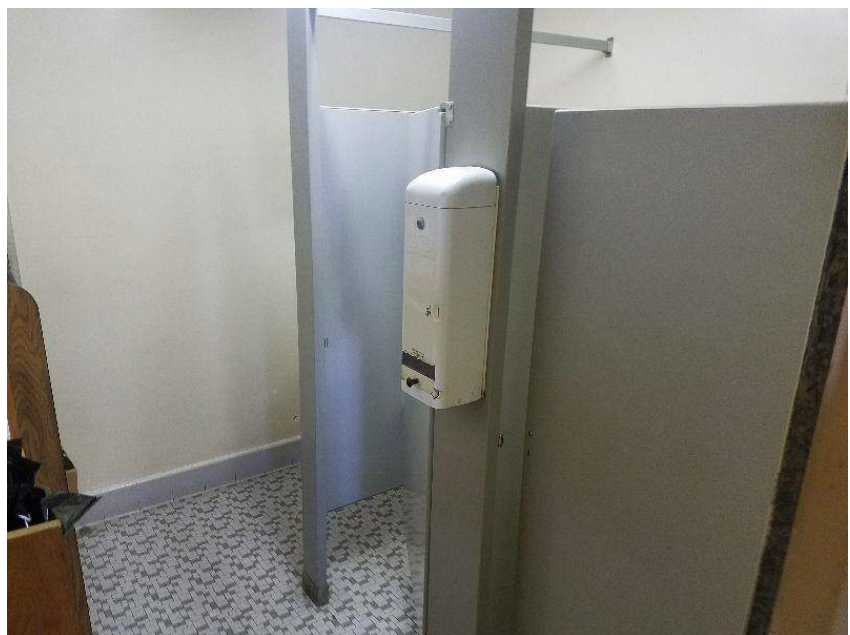
BATH 1:

Women's bathroom which is upstairs. There are two toilet stalls and the sink.

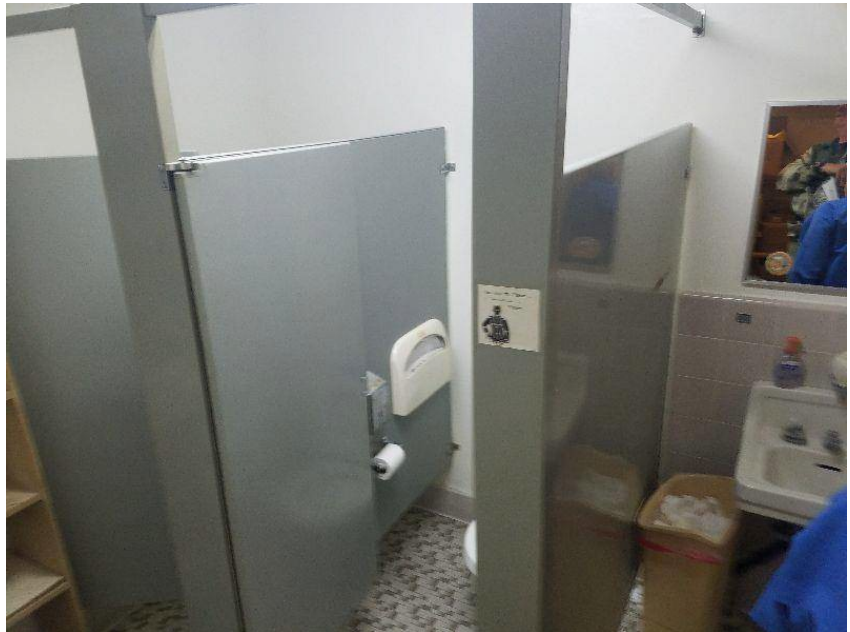
BATH 2:

The men's bathroom upstairs is also a 2 stall toilet and the sink and there is access to the attic or above ceiling area from this room.

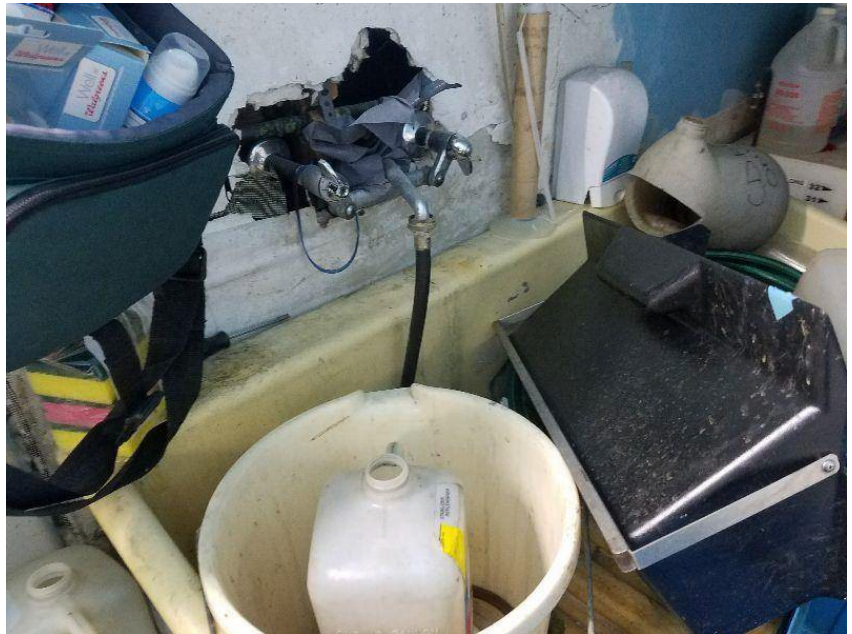
JANITOR CLOSET :

An old free-standing sink for possibly processing film which does not appear to be in use currently.

Needs Attention:
SINK: The sink is chipped / rusted/ very stained.

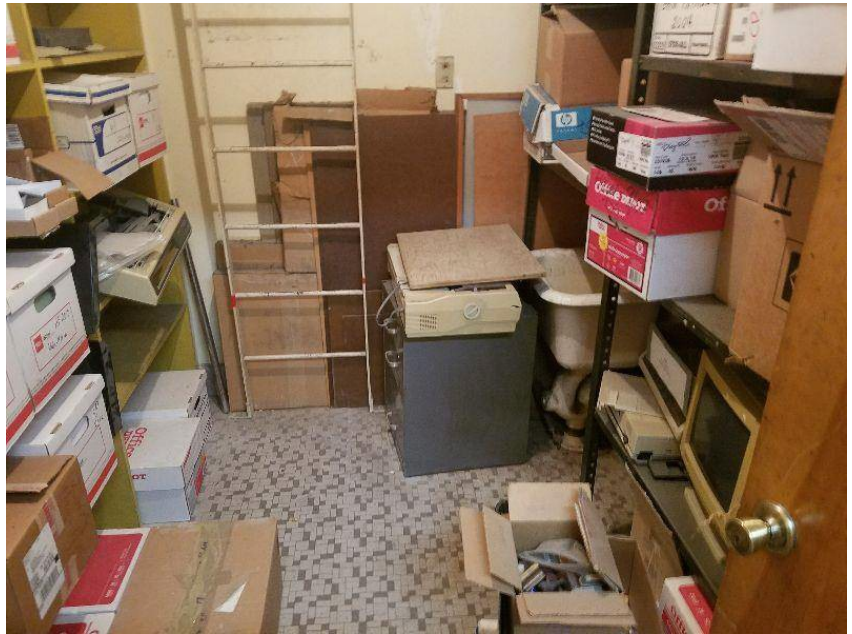
UPSTAIRS JANITOR
CLOSET :

This is a storage room with a janitor type sink and a short ladder and access to the roof is through this.

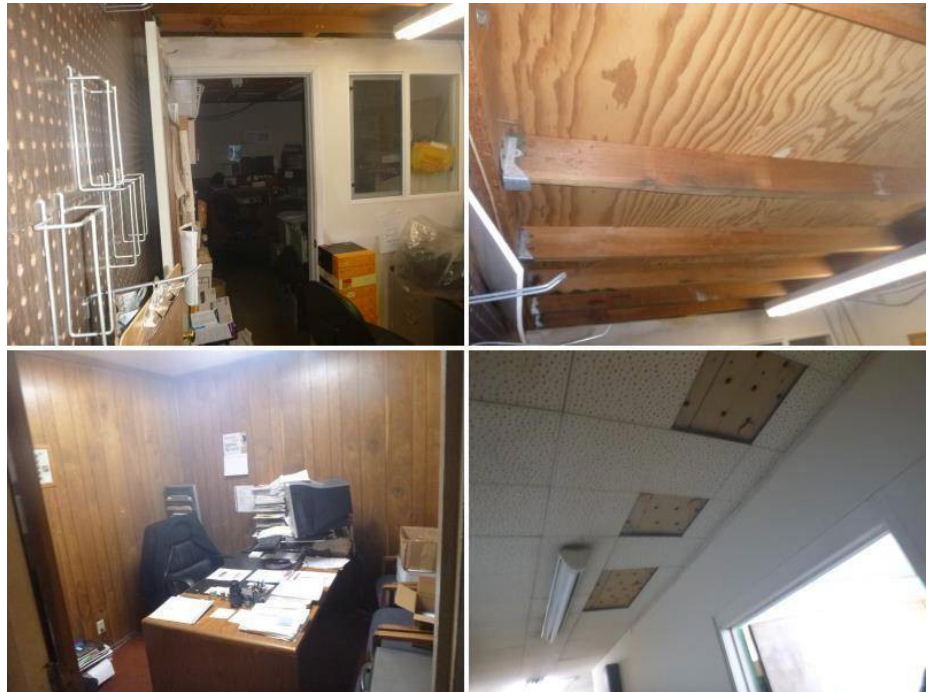
Note light duty 2x4 supports are used for the mezzanine floor supports.
